Scott Home Inspection, LLC

### Inspection Picture of the Month:

**Preventing future roof leaks:** A common inspection item noted during a roof inspection is the plumbing vent rubber boots are cracked or damaged.

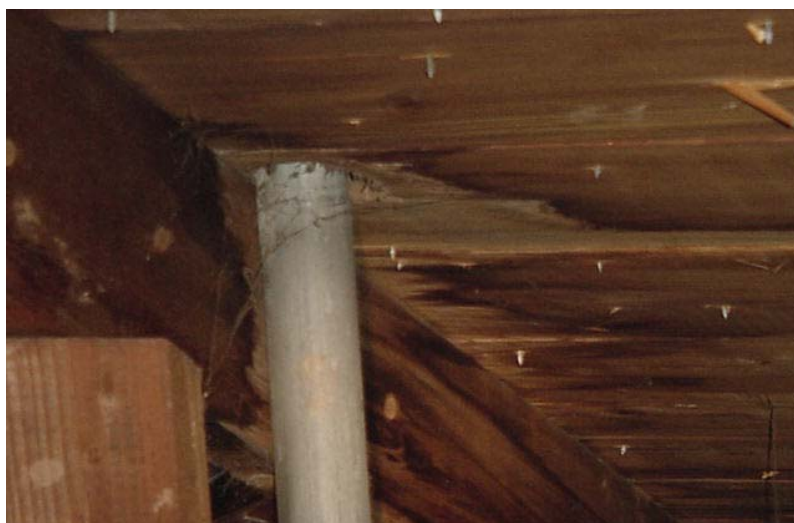
While this problem seems minor in nature, this is a perfect opportunity for moisture to enter the attic space, run down the sheathing and into the home, causing drywall damage, truss damage, etc, as shown below.

When this condition is discovered, a roofer or roof repair company needs to replace these vent flashings. Caulking can be done as a temporary solution, but will need to be repeated periodically. At the time of a roof replacement, these flashings and boots should all be replaced as well.
